Effects of bank vegetation in waterways with special reference to bank erosion, shear strength, root density and channel hydraulics

**Effects of Bank Vegetation in Waterways with Special
Reference to Bank Erosion, Shear Strength, Root Density and
Channel Hydraulics**

**A thesis submitted to the Open University
for the Degree of Doctor of Philosophy
Biology Department
September 1992**

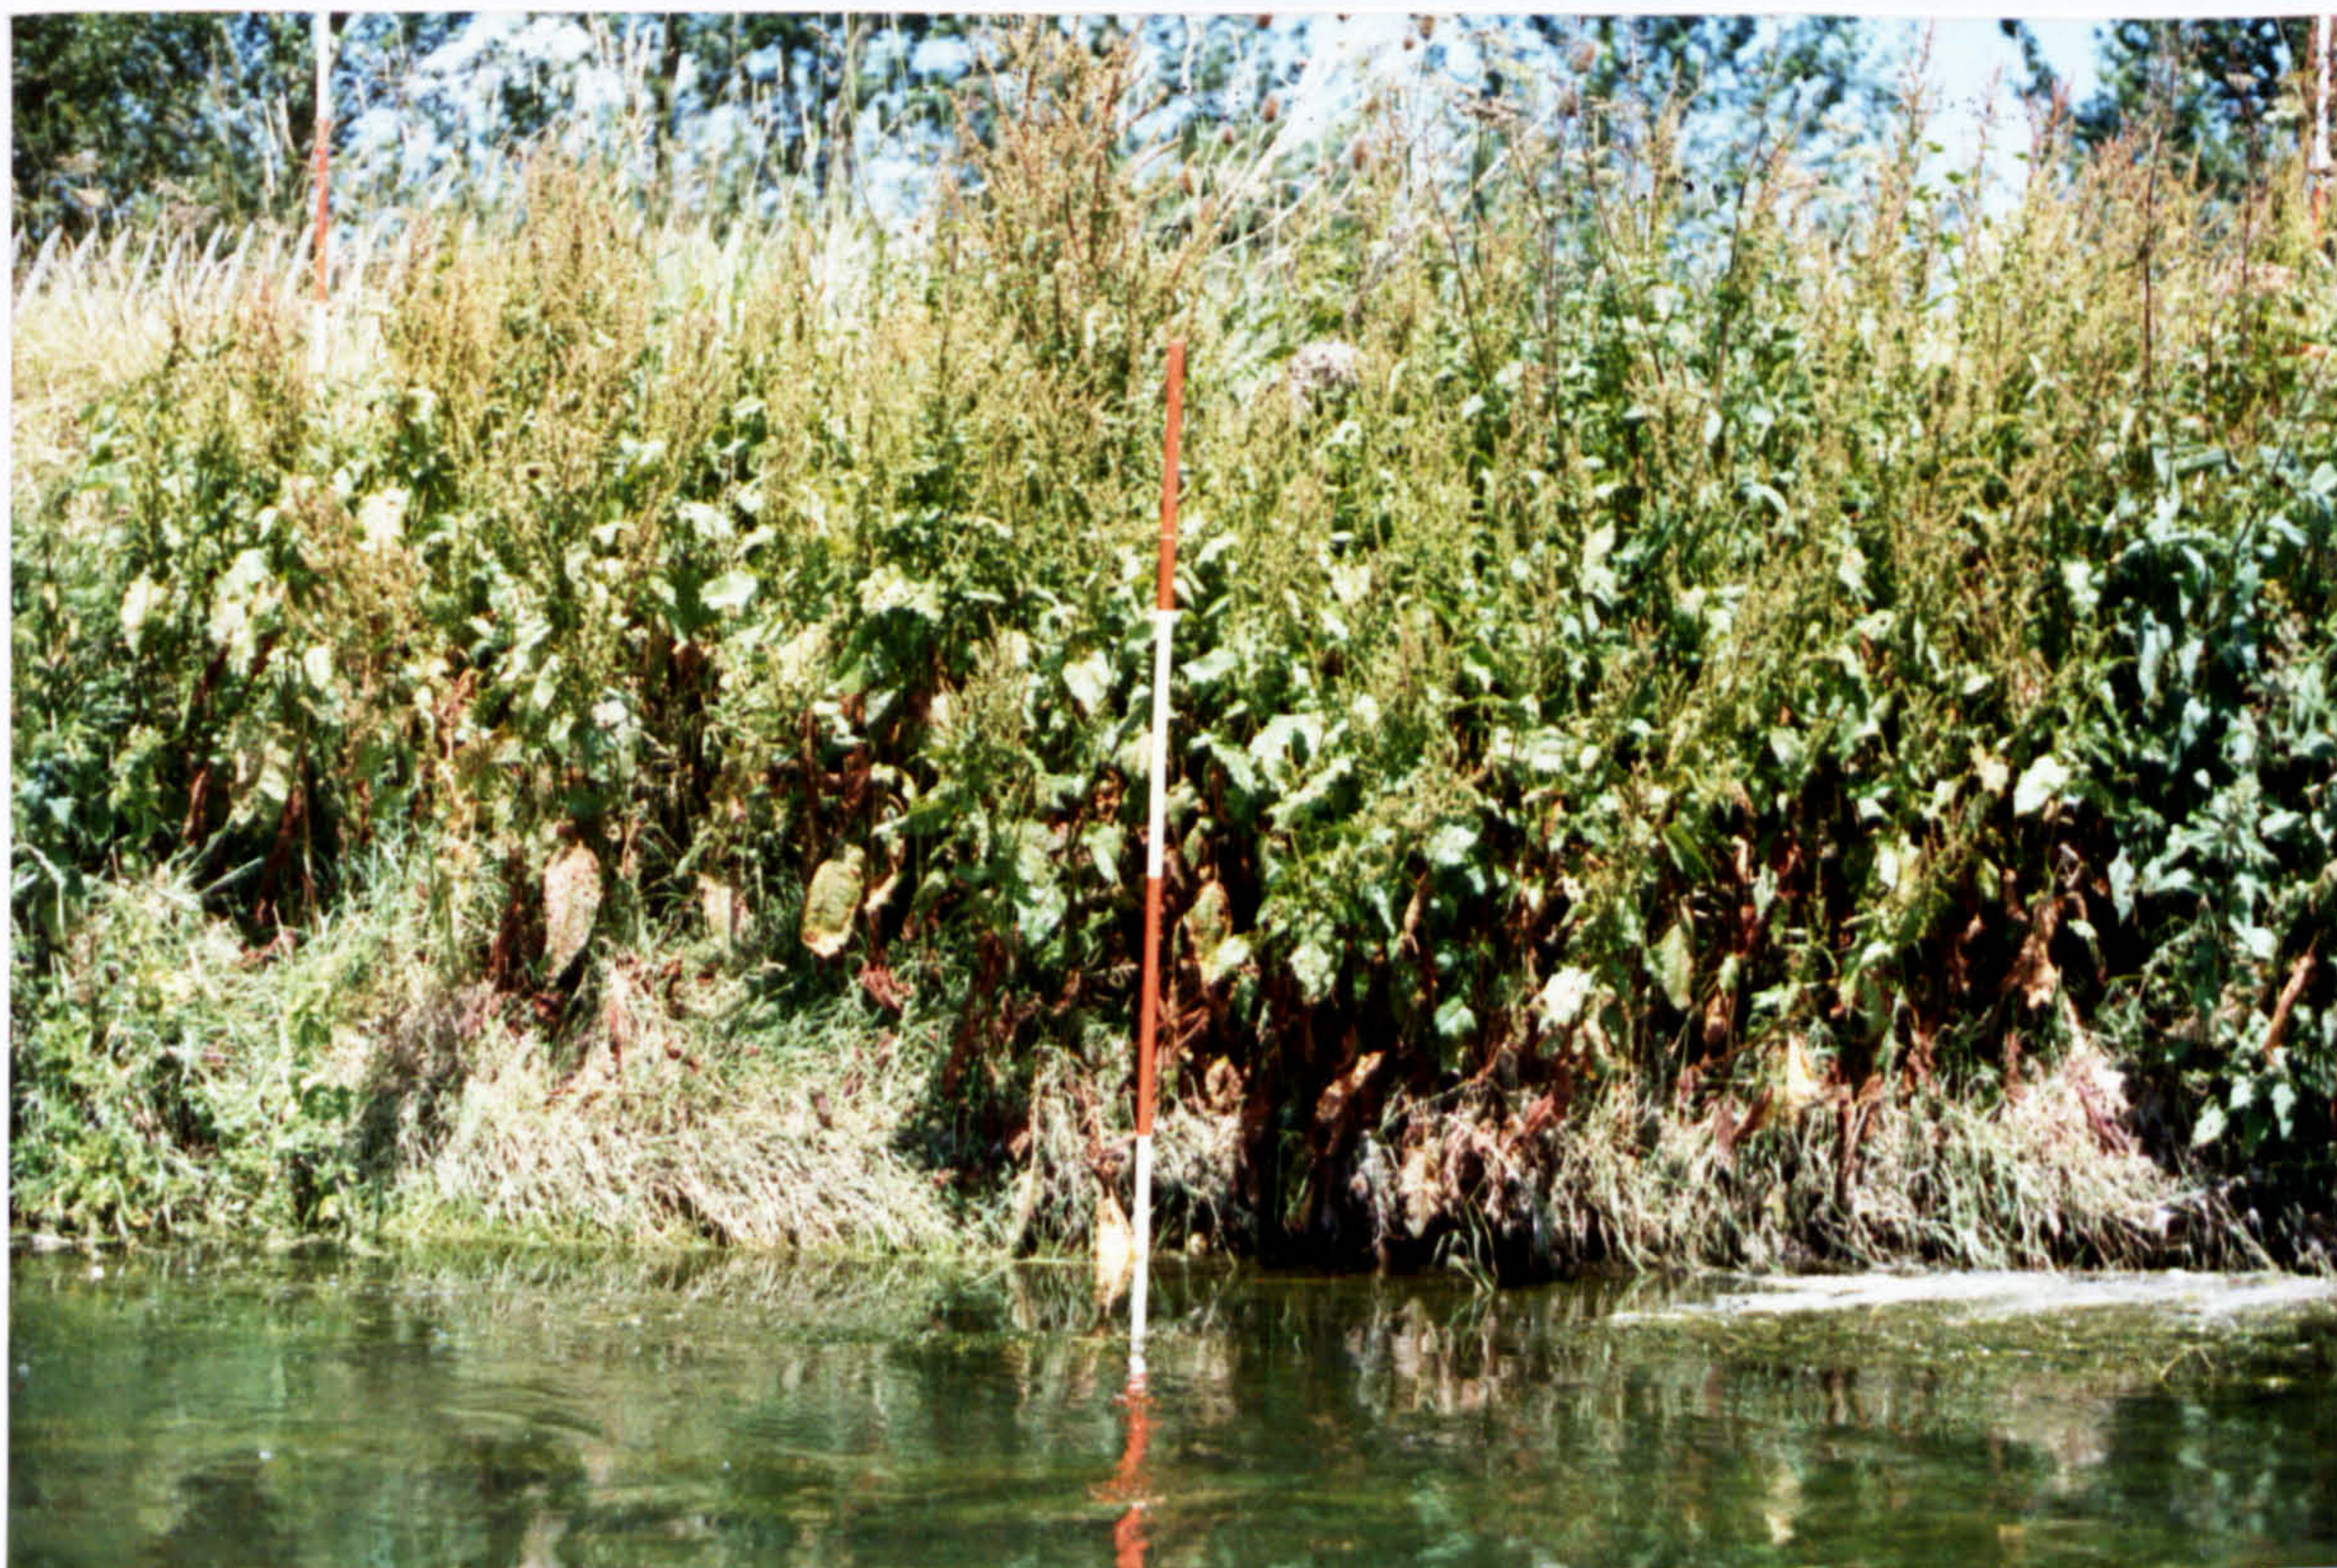
Plate 12. Lower and mid-bank colonisation in a naturally re-vegetated plot (August 1988)
 N.B. *Rumex* spp. and grasses dominate this region as a pioneer coloniser in secondary succession

Colonisation is sparse in April 1987. By September 1987, wetland bank vegetation such as *Glyceria maxima*, *Ranunculus sceleratus* and *Veronica spp.* are noted; *Rumex spp.* are present. The May 1988 data show that this region is mostly colonised by *G. maxima*, *Juncus spp.*, and *Cirsium spp.* (see Plate 12 for August 1988).

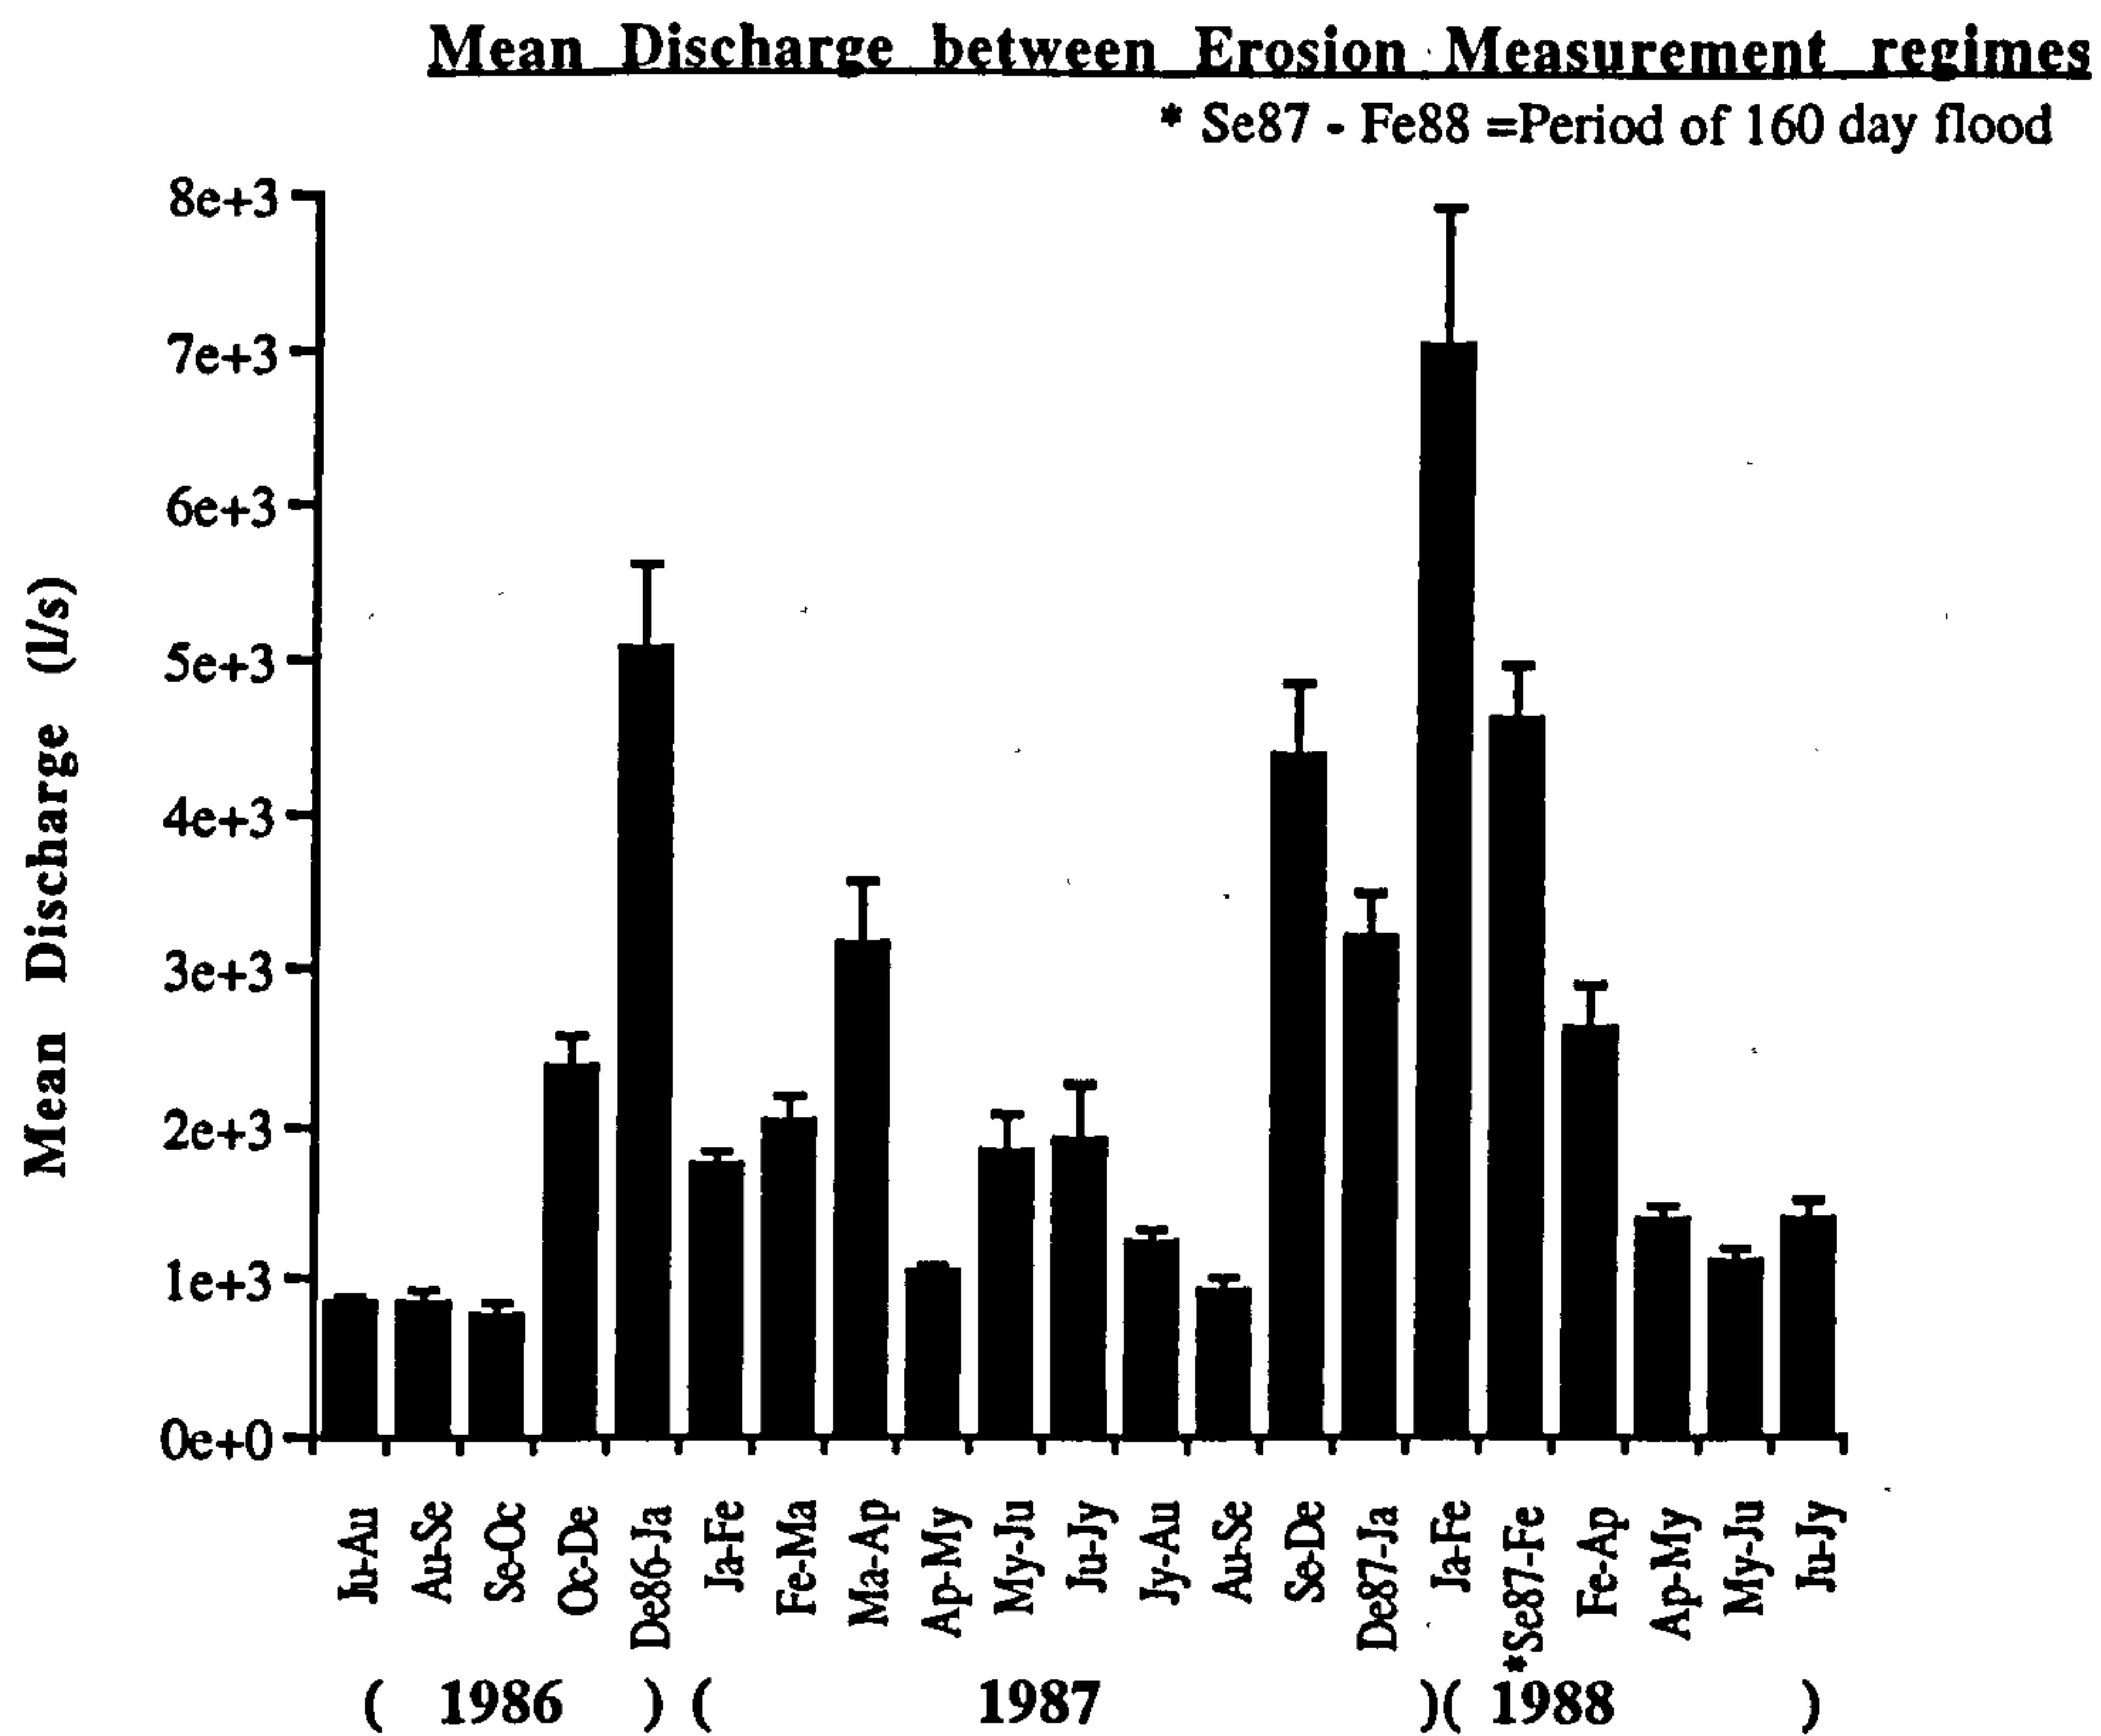
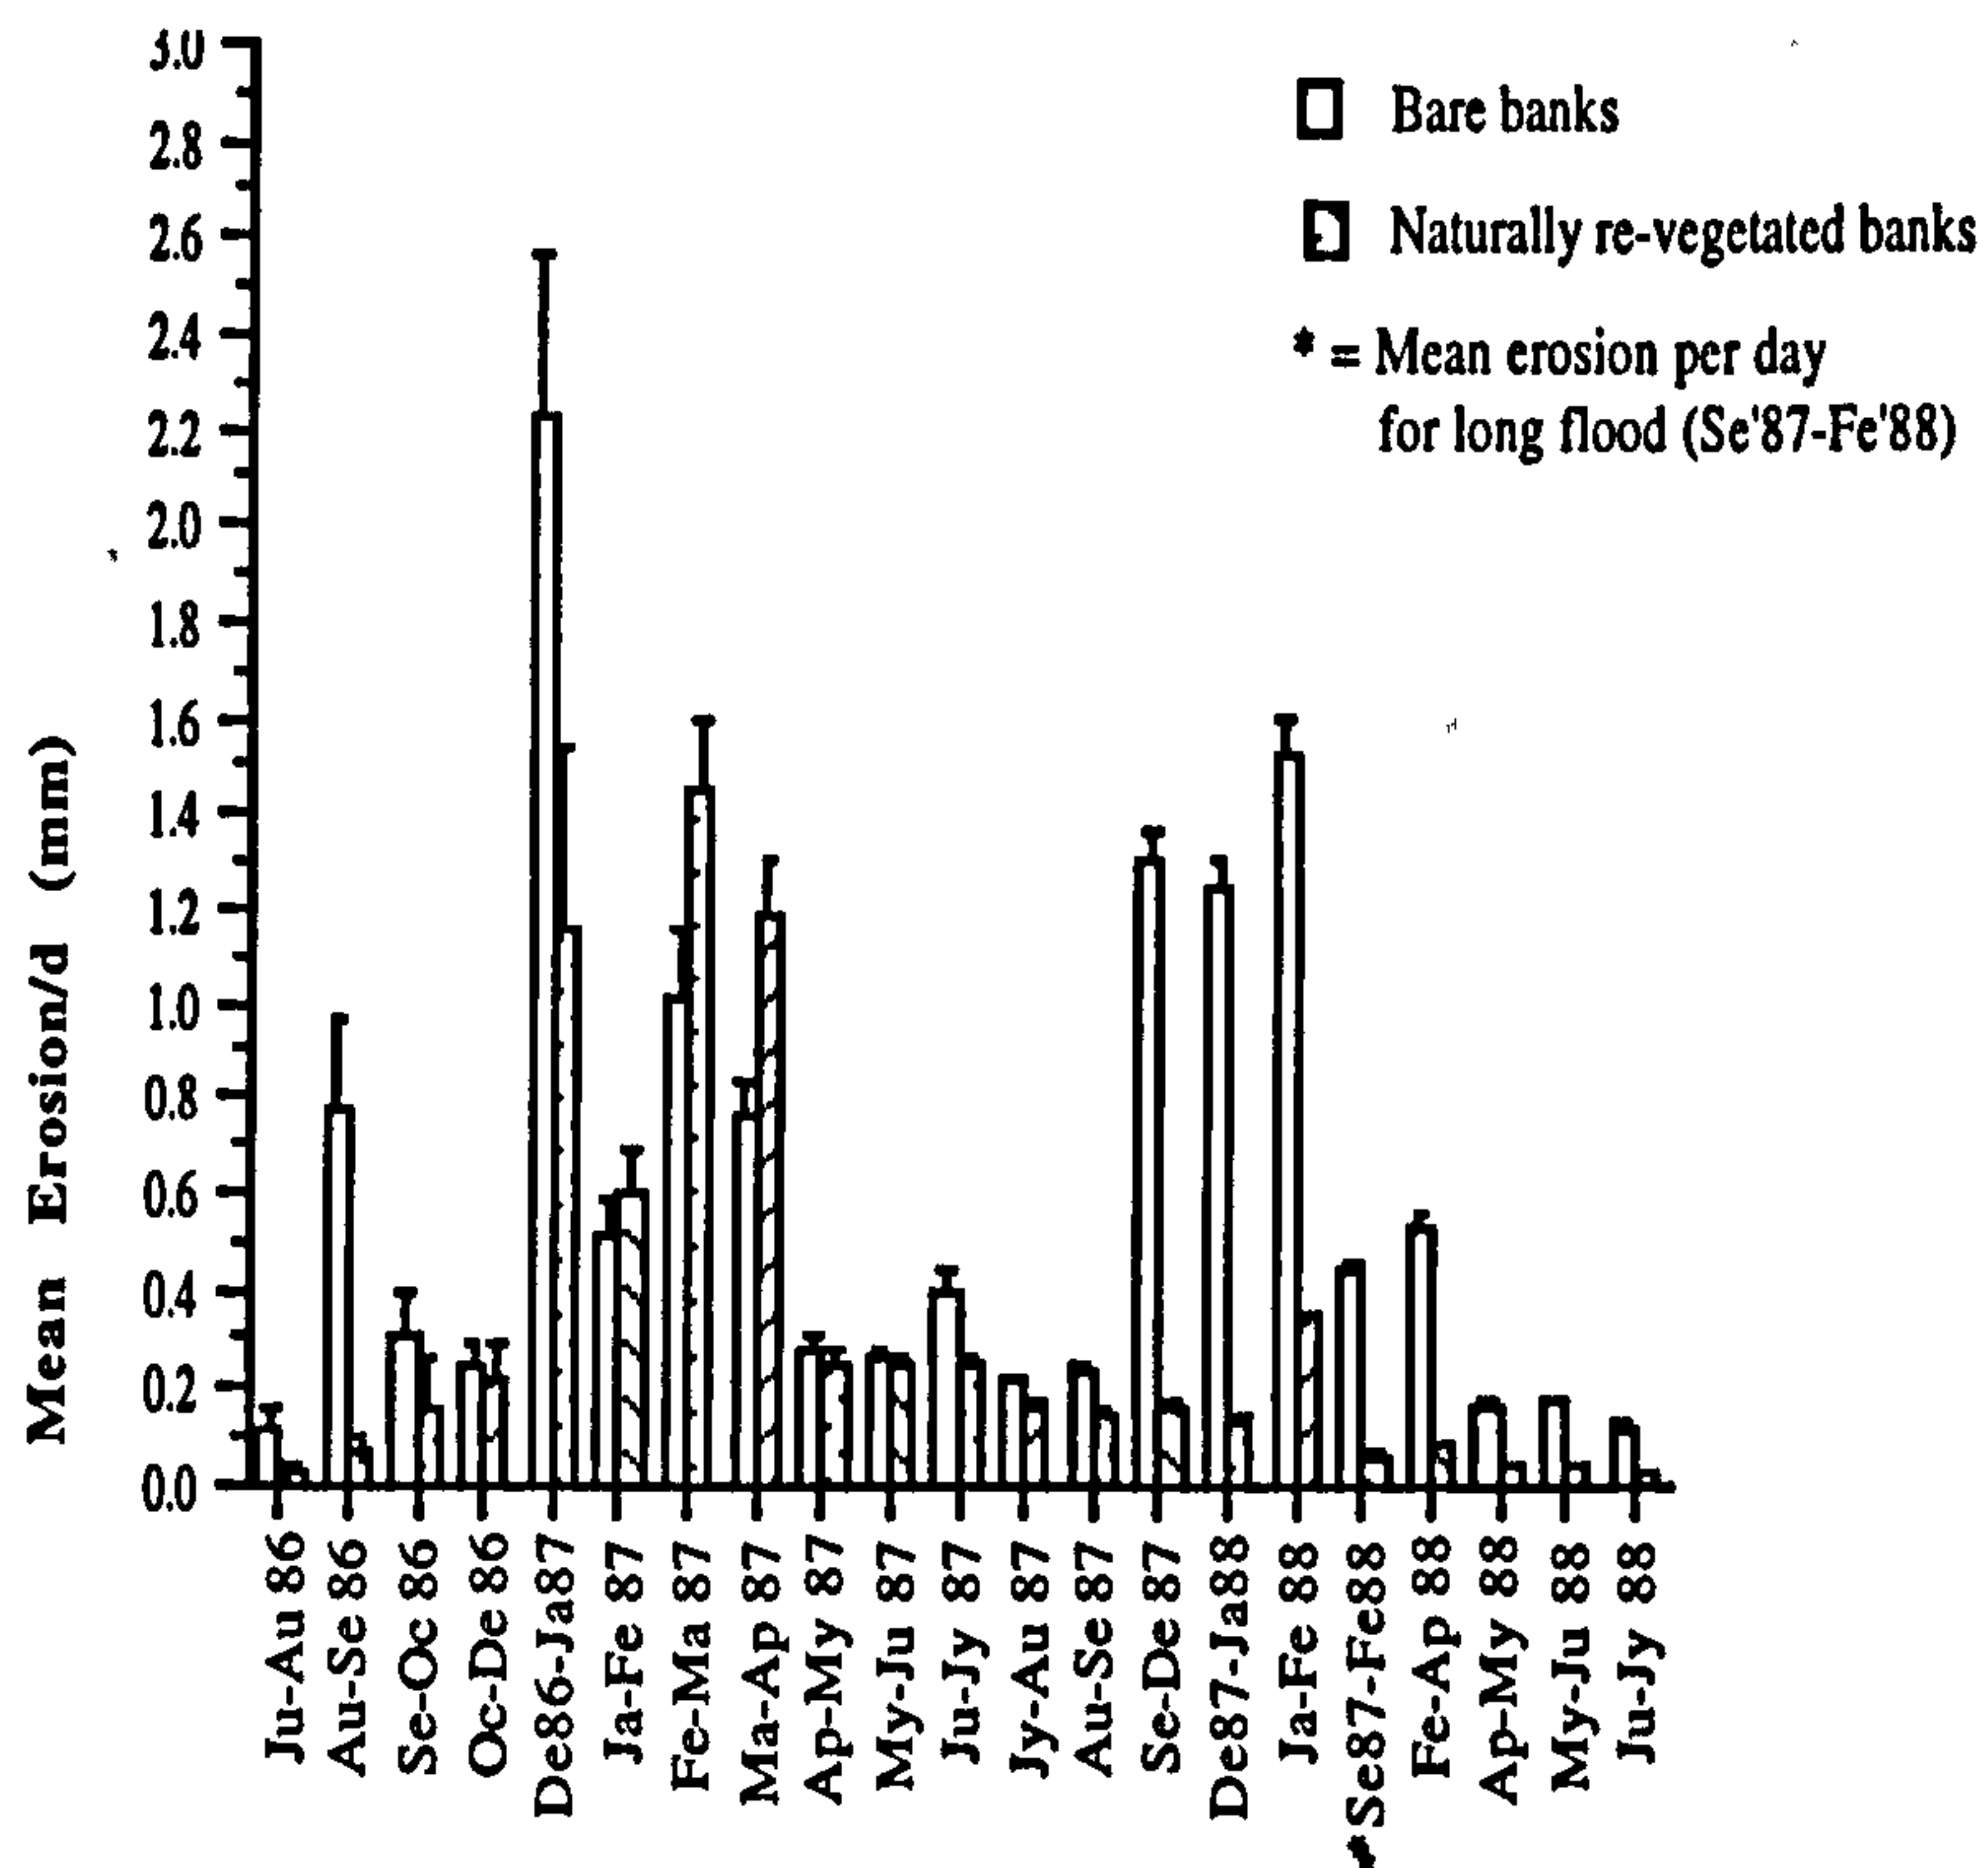
Fig. 5.1 : Comparison of erosion : Bare soil Vs. Natural re-vegetation (whole banks)

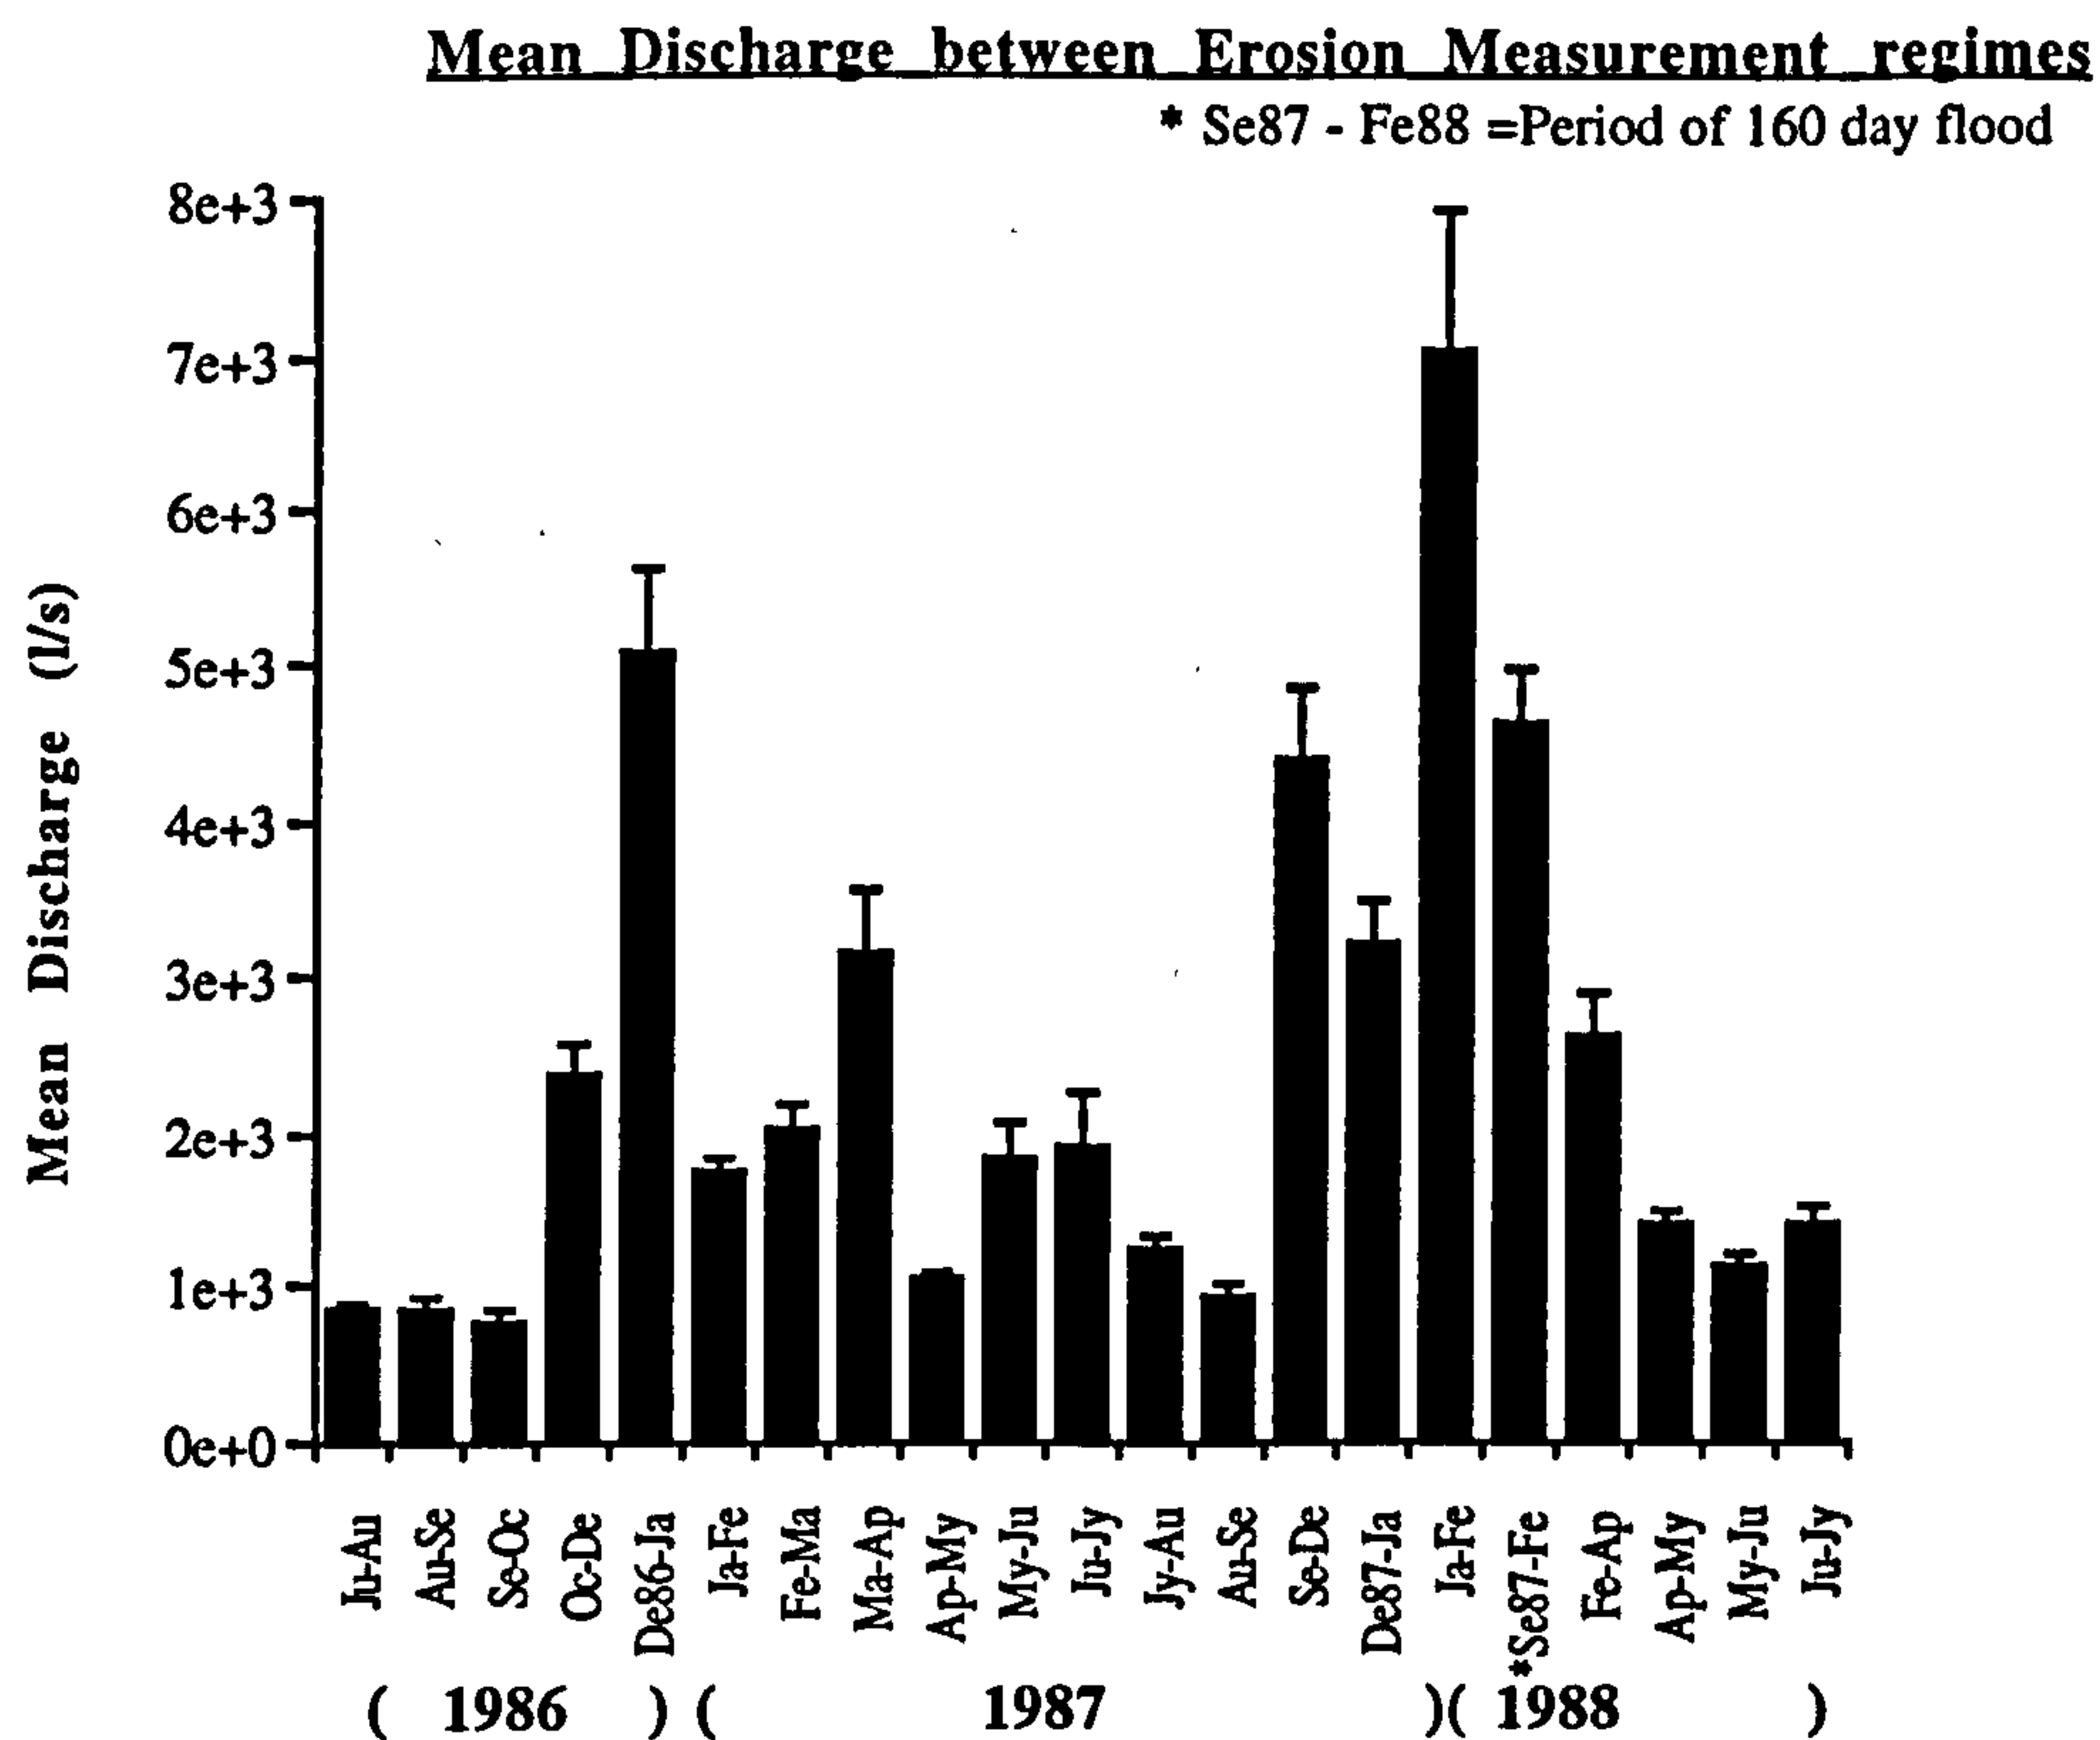
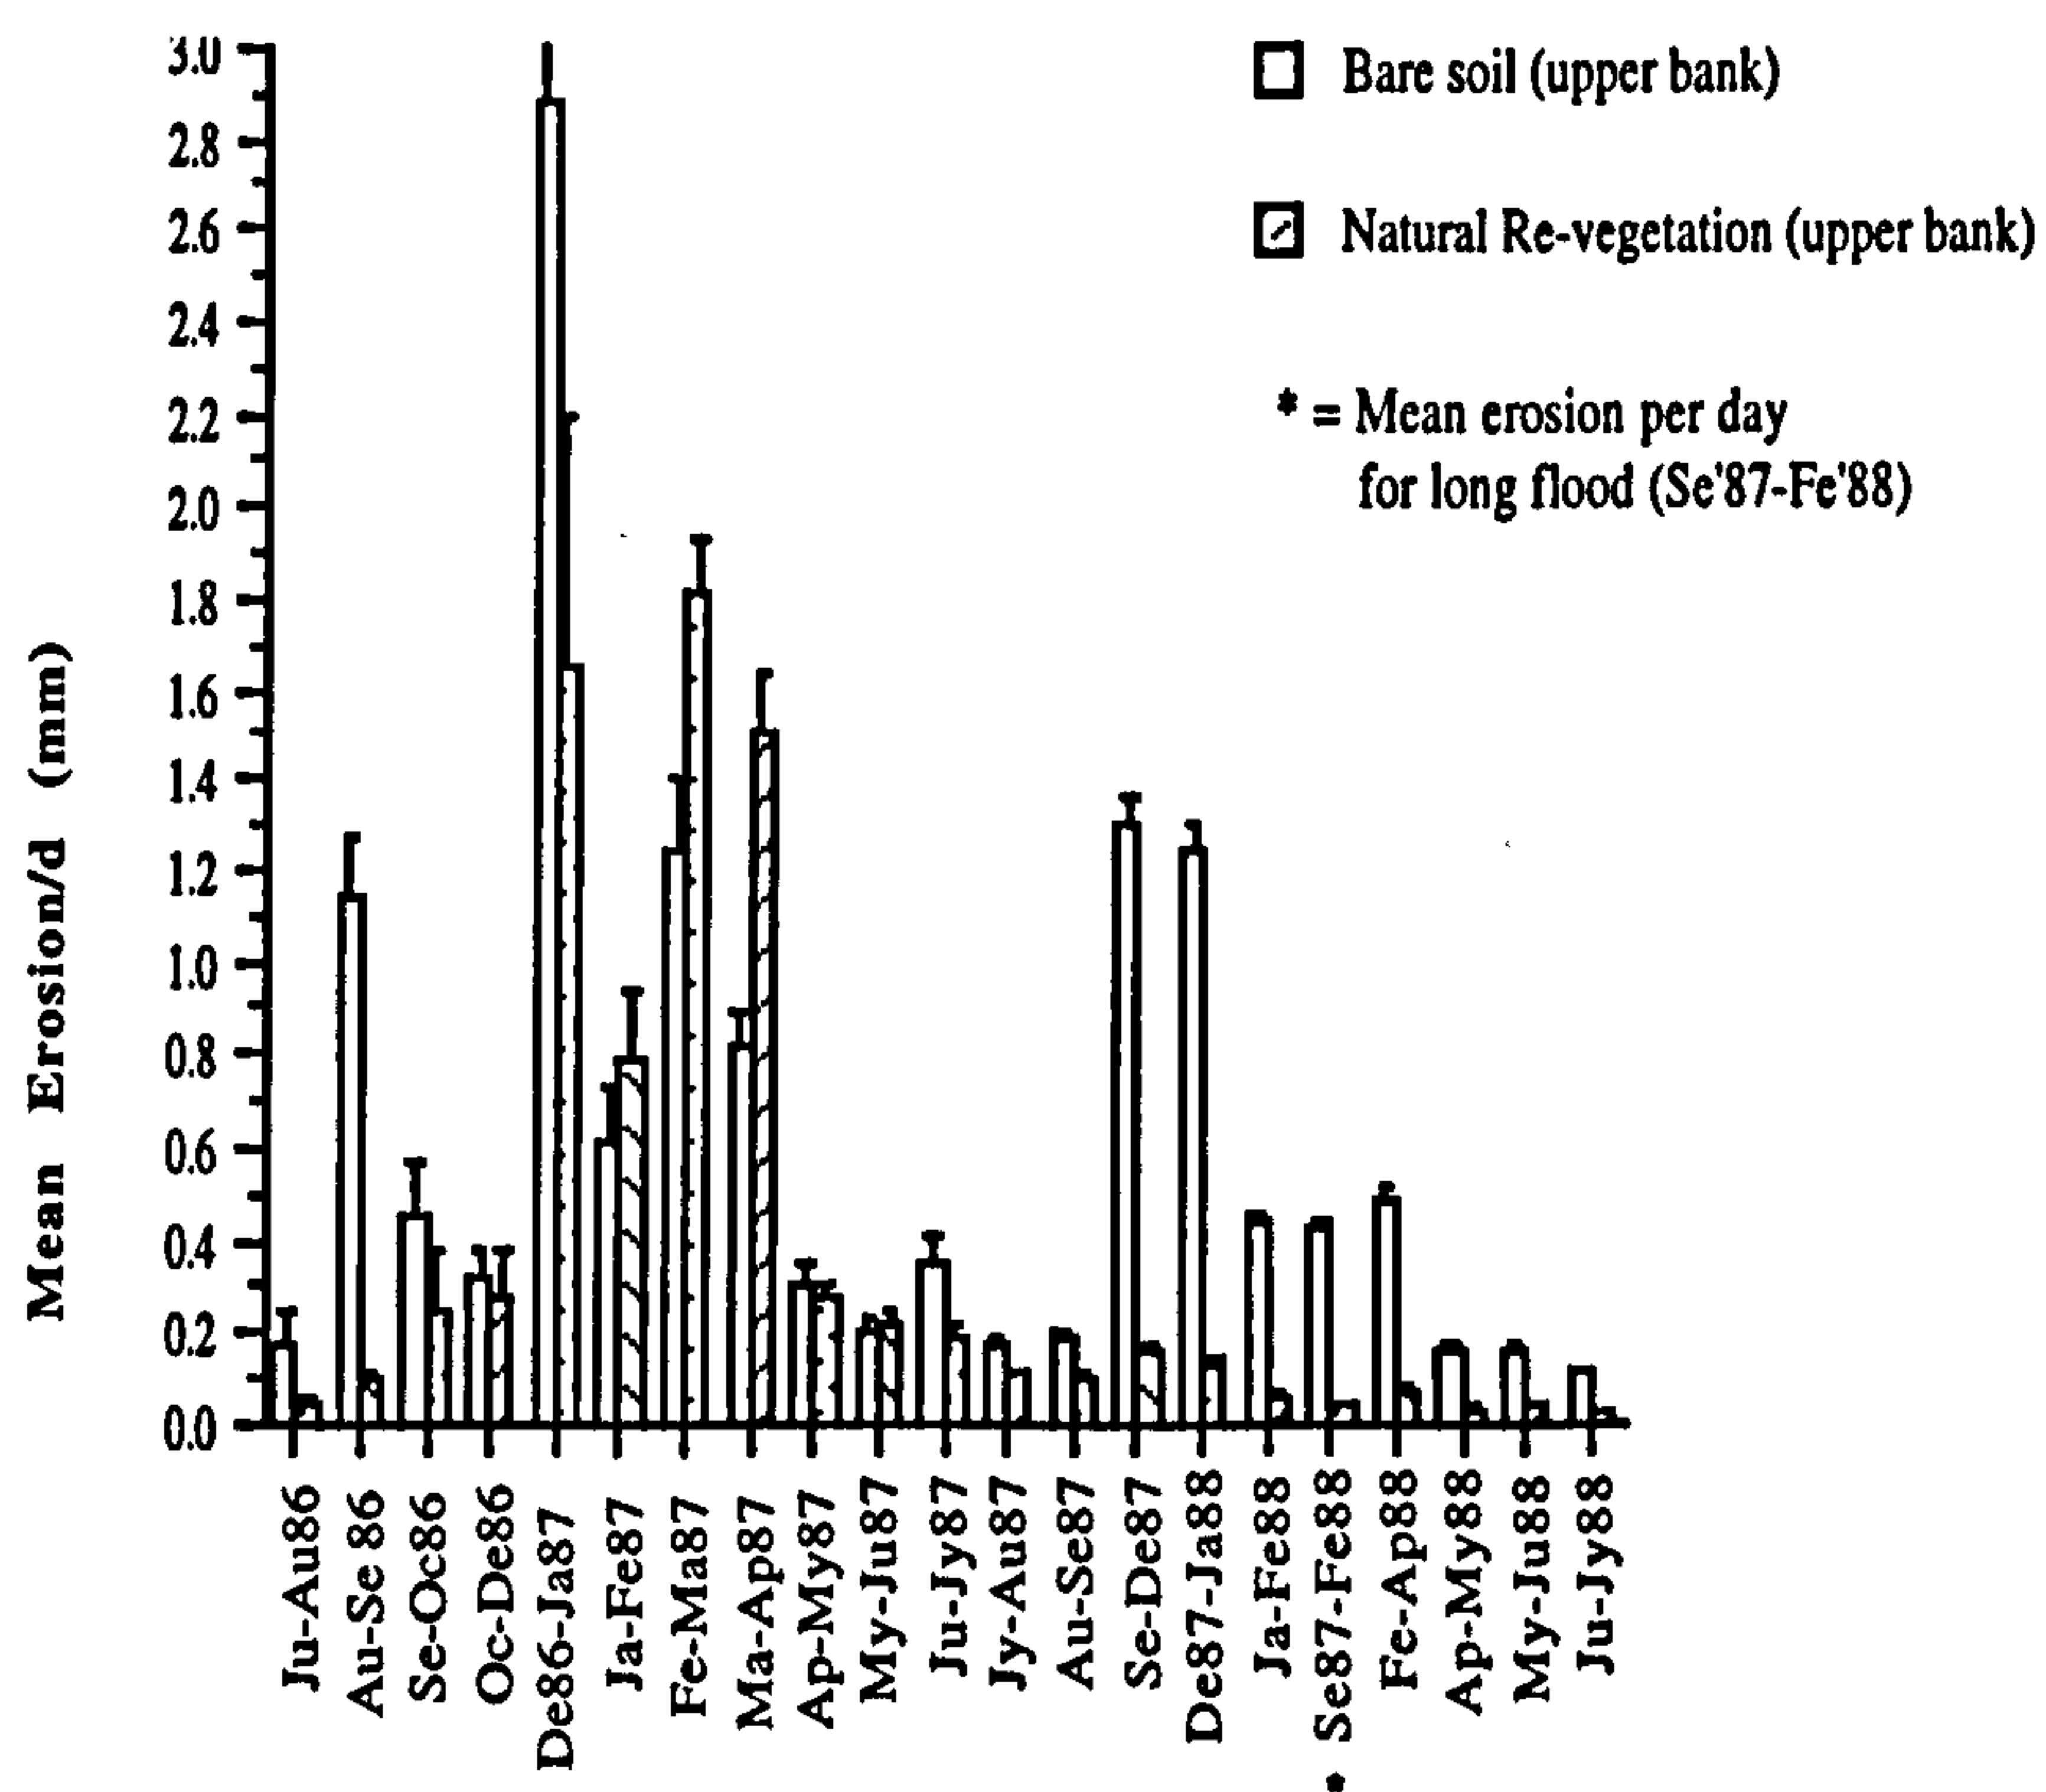
Fig.5.2 : Comparison of Erosion : Bare soil vs. Naturally Re-vegetated banks; (upper bank)
